USARTL-TR-78-7

CRASHWORTHY GUNNER SEAT TESTING PROGRAM

M. J. Reilly **Boeing Vertal Company** P.O. Box 16858 Philadelphia, Pa. 19142

Final Report for Period May 1975 - December 1977

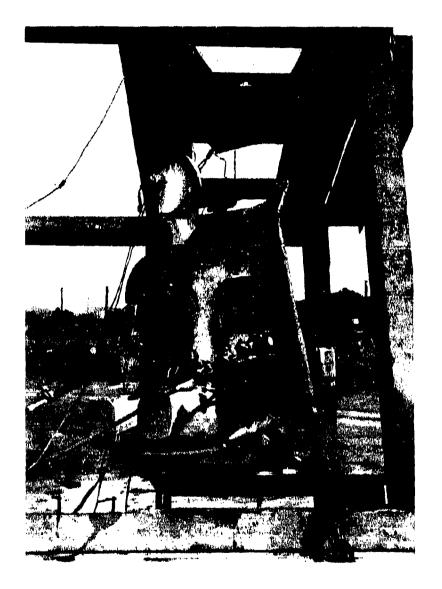
Figure 28. Post-test 4A, fully stroked seat.

10.5 in. in a forward direction. The test was stopped at this point and the load maintained for several minutes while a visual inspection was made (Figure 28).

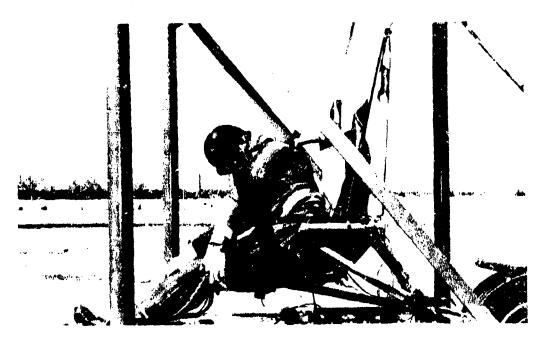
Figure 45. Post-test 3, lost shoulder restraint.

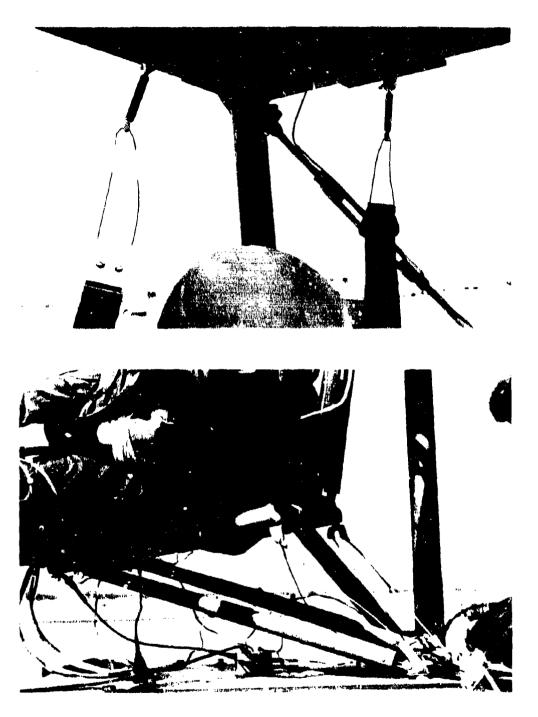
The upper and lower energy attenuators stroked, all functioning properly (Figure 65). The upper right and left attenuators had stroked 8.5 and 5.0 in.respectively. The front diagonal strut stroked 6.4 in. and the rear strut stroked 6.0 in. The right diagonal cable had stroked 1.2 in. and the left diagonal cable had stroked 1.5 in.

Figure 65. Stroked upper and lower attenuators.
